Manhole Inspection Summary

Manhole # S31GG_022MH

Insp Date: 1/23/07 1:53 PM

Location Address: **1111 PARK AVE**

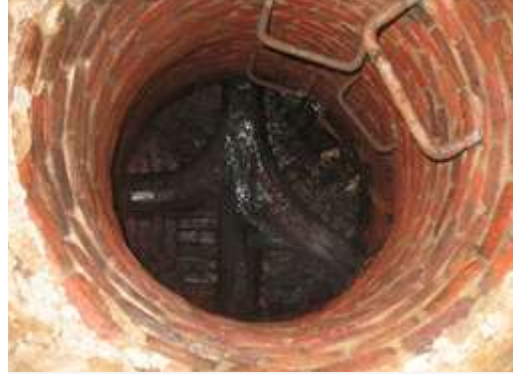
Top View

Corroded steps. Bench debris.

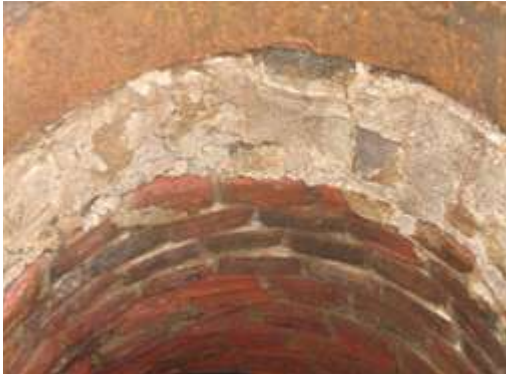
Defect

Frame offset. Adjustment infiltration.

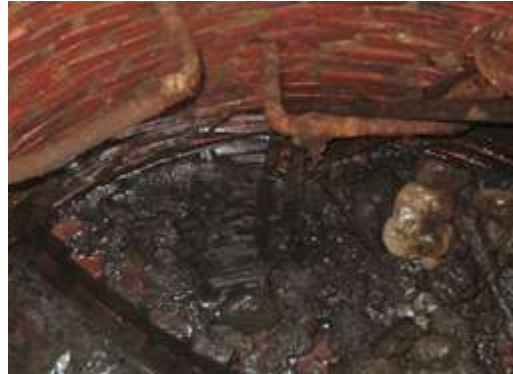
Defect

Corroded steps. Evidence of surcharge - Bench debris.

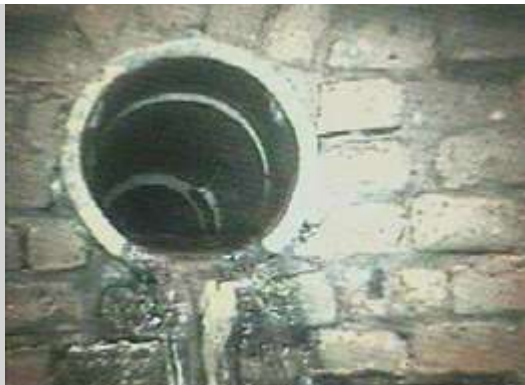
8 in. Circular Gravity Sewer Pipe In @ 5 O'Clock

Infiltration: **Evidence** Pipe Seal Cond: **Unknown**

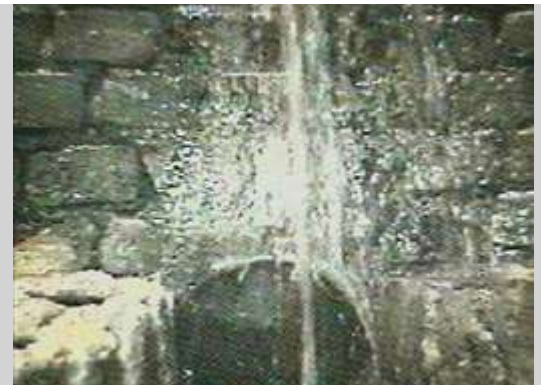
Drop In @ 5 O'Clock

Barrel deterioration and infiltration.

Drop Condition: **Clogged**

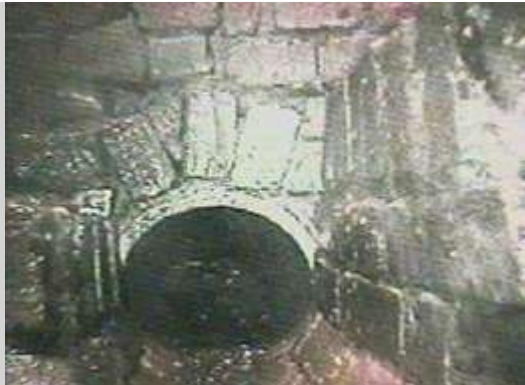
Pipe In @ 6 O'Clock

Barrel deterioration and infiltration. Channel deterioration.

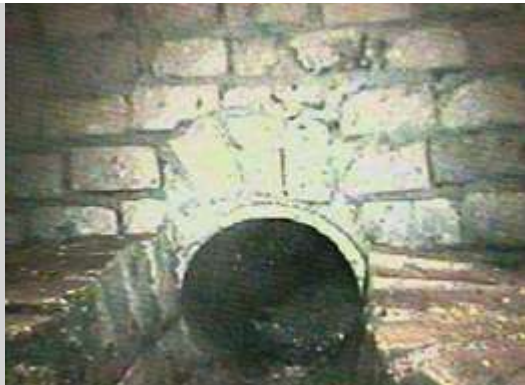
Pipe In @ 9 O'Clock

Deposits: ☐ None ☒ **Mud** ☐ Sludge ☒ **Debris** ☐ Grease

Silt Depth: **0** (in.) Deposits Extent: **Light**
